**National
Transportation
Safety Board**

NTSB Update: Maintenance- Related Accidents

Accident: Beech 36

Accident: Eurocopter AS 350B2

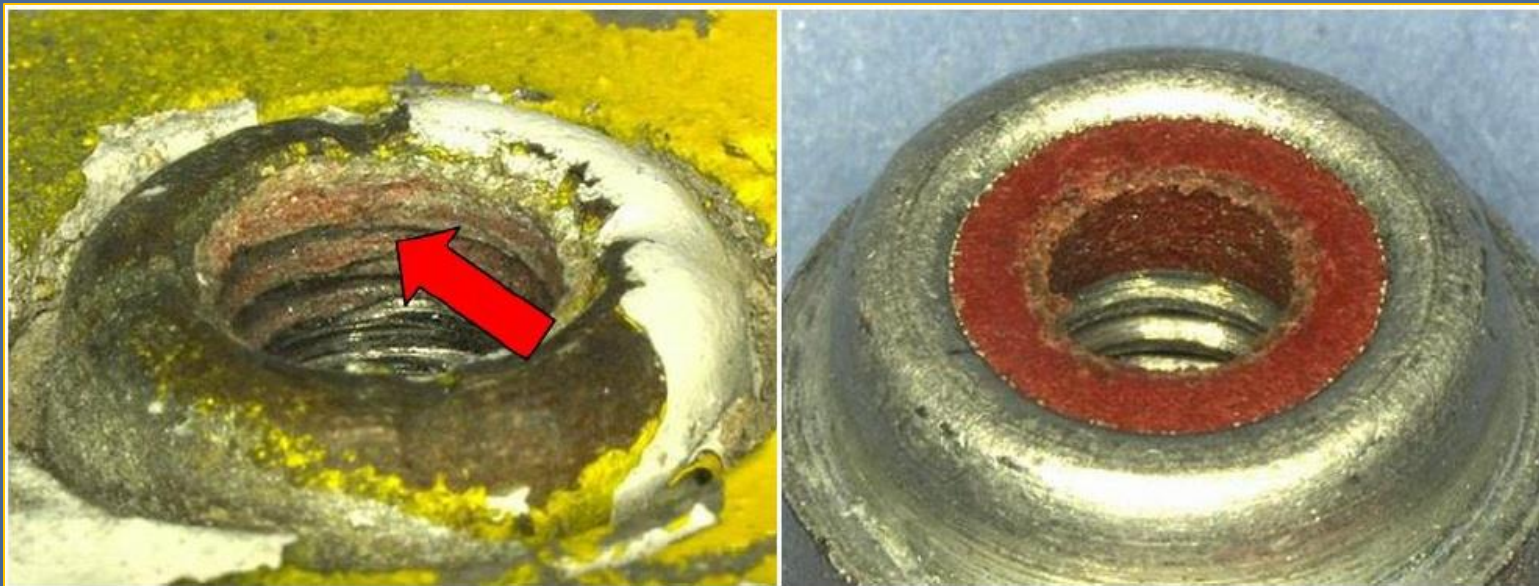
Self-Locking Nut Reuse (Reno)

Deteriorated self-locking nut was one “link in the chain” of P-51D crash in the 2011 Reno Air Races (note separated elevator trim tab)
